Britannia's Environment

A look into the 20th century environmental legacy of the Britannia Mines and its 21st century success story.

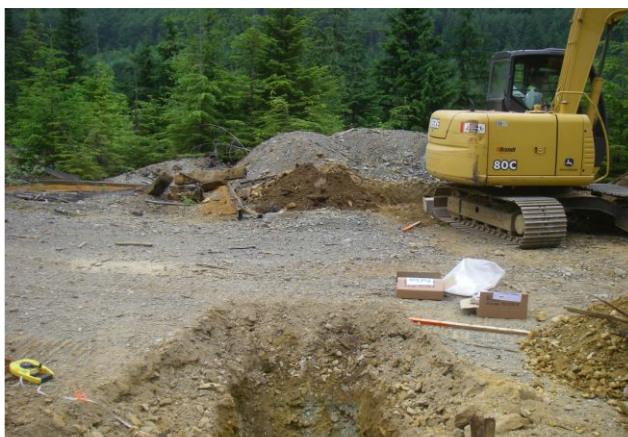
Test pitting near the 2200 Level portal in 2008

In 2001, the University of British Columbia installed a concrete plug at the 2200 Level portal (around 600 m above the water treatment plant). This stops mine water exiting there. Before the plug, around 30% of the water left the mine at this portal, badly polluting the Britannia Creek and contaminating the nearby ground.

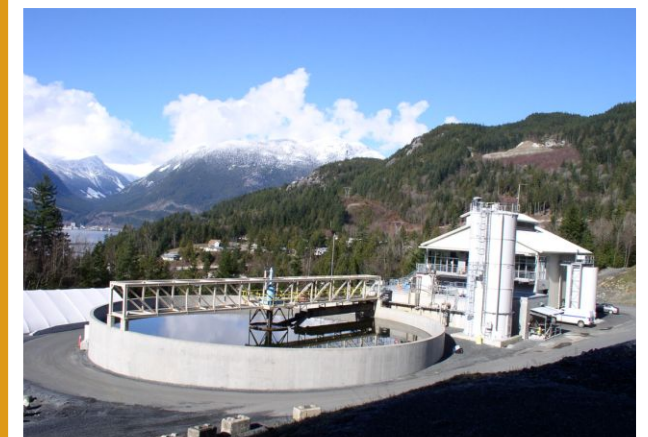
EPCOR Water Treatment Plant

On arrival at the facility, the water is first treated with lime slurry (a mixture of lime and water) in two reactor tanks. The alkaline lime neutralizes the acidic water, quickly raising the pH from 3.8 (ARD) to 9.3. At pH 8.5, the dissolved metals naturally come out of solution and precipitate as tiny particles. The most amount of metals precipitate at pH 9.3.

The water is then fed into a large 'clarifier' tank where a customized, man-made polymer is added. This electrostatically attracts the metal particles, forming clumps that sink through their own weight, creating a dense sludge at the bottom of the tank. This is removed, and the clean water is discharged into Howe Sound. By the time the water reaches the sea, its pH has naturally decreased to around neutral.

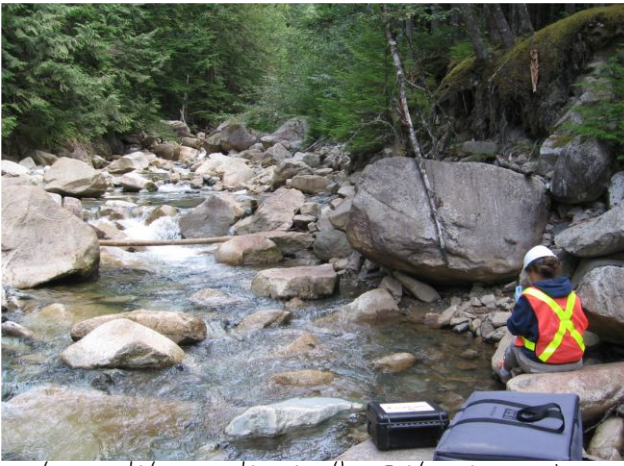
Water quality sampling in the Britannia Creek

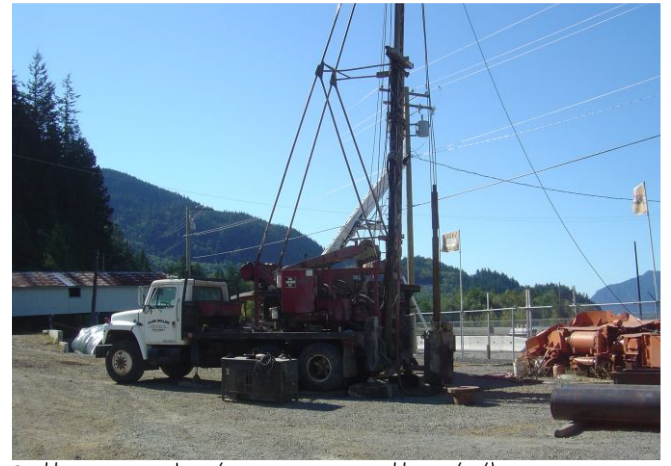
Drilling groundwater pumping wells at the Museum

There is also a pumping station on the foreshore at Britannia Beach. This collects groundwater from 9 nearby wells. Once collected, this polluted water is pumped up to the water treatment plant and treated with the rest of the ARD. As of 2008, plans are being

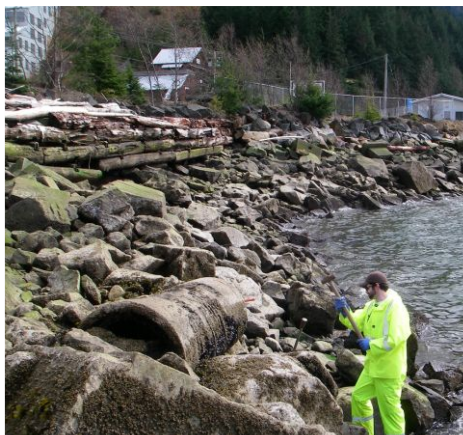
installing a piezometer, 2008

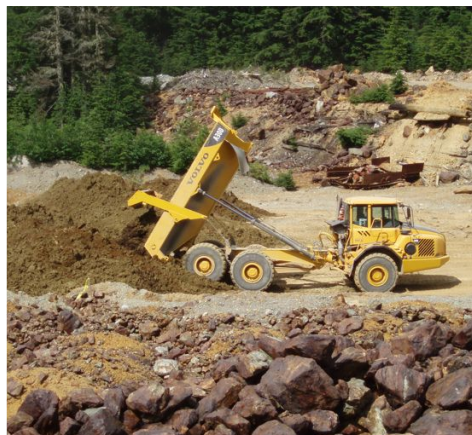
Dumping sludge in the Jane Basin

The sludge is stored on site until it can be taken up to the Jane Basin mining pit, where it helps cap the pit. As the metals are no longer in the form of a metal sulphide, they won't react with air and water to form ARD. Also, as the pH is now slightly alkaline, any water runoff into the mine will help to neutralize the acidic water in the mine.

The original Jane Basin mining pit high on the mountain was partly infilled by construction waste rock at the beginning of the remediation project, and is now infilled with metal sludge from the treatment process. Although it will never cap the pit, it will help to reduce the water that seeps into the mine tunnels. Also, water from above this open pit is being diverted, to reduce the amount of clean water flowing into the mine - which would then become polluted.

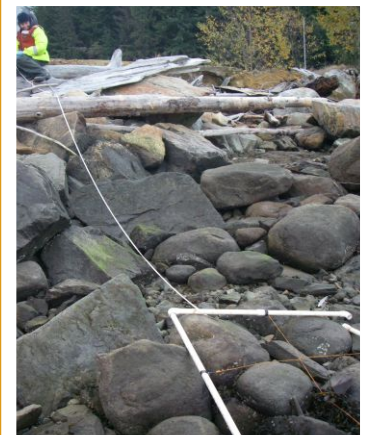
Shoreline biomonitoring, 2008

In the few short years that the remediation campaign has been taking place, Golder Associates have been monitoring the shoreline at Britannia for dissolved metal levels and for its ecology. There are currently still some hot-spots - the focus for future work, but the shoreline and sea water quality is definitely showing signs of improvement and of the life that is now able to live there.
